Photos From the Road

My Not So Relaxing Vacation

By Emily Wilder, Kansas LTAP

Kansas LTAP Newsletter – November 2019

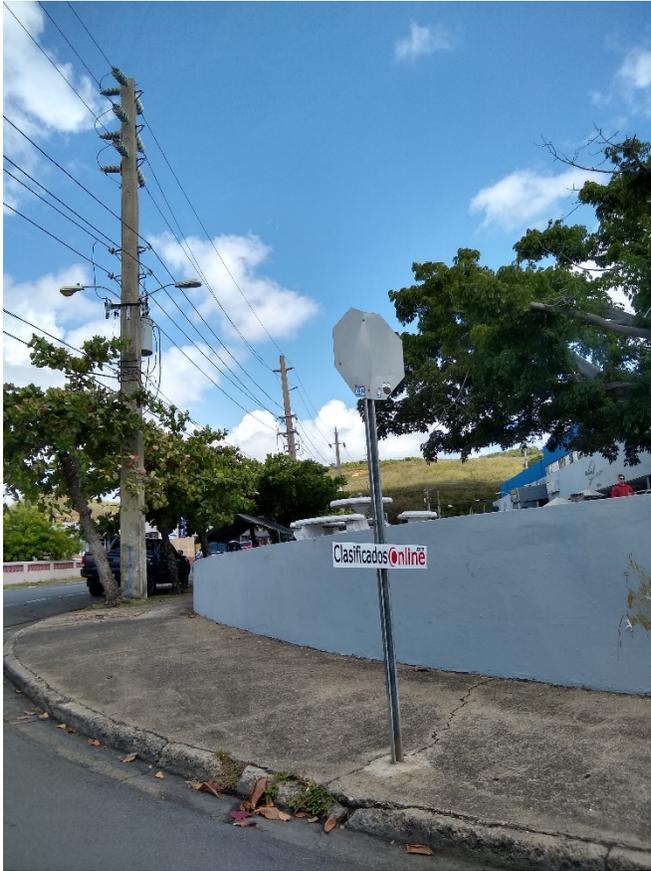
This picture was taken during my trip to Puerto Rico this past summer. Now, I know what you're thinking – "It's Puerto Rico, are they even bound by the MUTCD?" Yes! Puerto Rico has adopted the national MUTCD along with a State supplement. With that being said, run down, worn out signs were pretty common, if

For this sign, you can tell from the octagonal shape that this is the pale ghost of a STOP sign. The bold letters and bright red that we're used to seeing have long since vanished. Also note the size, it's much smaller than the standard STOP signs we see in the US. So far, there are two main differences from the traditional STOP sign – Color and Size. According to the national MUTCD, "with the exception of symbols and colors, minor modifications in the specific design elements of a device may be made provided the essential appearance characteristics are preserved." (1) That tells us that the sign size may be compliant, but certainly not the color!

So here's a dilapidated STOP sign that is essentially a stationary off-roadway hazard. What should they do? Well, Section 1A.05 of the MUTCD covers the Maintenance of Traffic Control Devices and states, "Physical maintenance of traffic control devices should be performed to retain the legibility and visibility of the device, and to retain the proper functioning of the device." (1) I think the ship has sailed on maintenance. It is currently serving no purpose and either needs to be repaired. New sheeting on top of the metal would return this sign to good as new.
