# Kansas LTAP Fact Sheet

## Another Bridge Saved!

By Neil Cable, P.E., C.F.M., Saline County Engineer

*Some head-scratching and an innovative solution saved a corroding bridge.*

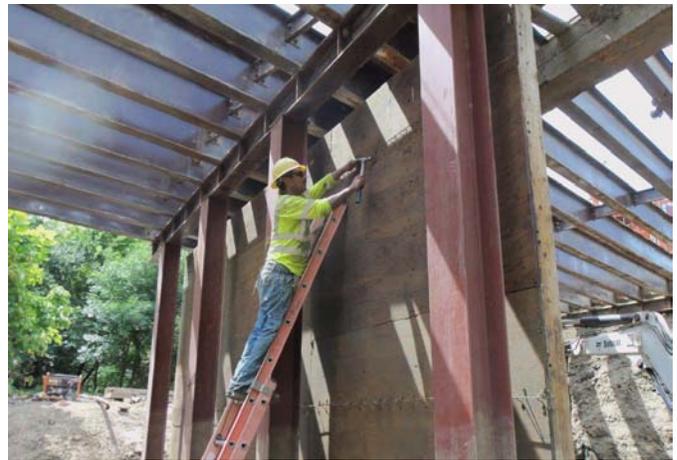
*Construction of formwork for subsequent encasement of the open H-pile bents with concrete.*

7. Concrete encasement of the open H-pile bents eliminates the proclivity of that type of bent to trap floodwater debris.

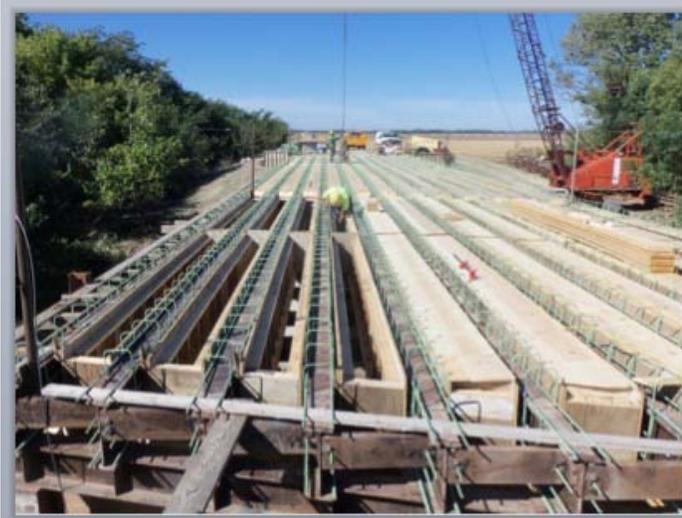
**At left,** placement of formwork and supplemental reinforcing around existing steel beams in preparation for concrete placement.  
**At right,** Removal of formwork after completion of concrete placement.

4. Monolithic placement of the concrete slab and girder encasement provides an excellent opportunity to supplement the beam strength with additional longitudinal reinforcement in the maximum positive and negative moment regions.

It was the end of October before all formwork, deck reinforcement, and supplemental girder reinforcement were in place. November 1st the concrete deck and

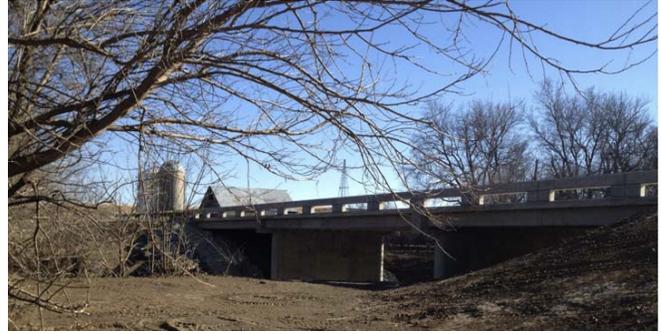
*The finished bridge.*

The completed bridge has no load restrictions. After more than a year in service, it exhibits no visible cracking in the deck or the concrete girder encasement. In fact, no one would know that the bridge had been a bare steel girder bridge that was exhibiting premature aging if they didn’t know its history. A subsequent project in the summer of 2014 placed a polymer overlay on the new concrete bridge deck to further protect the bridge from water penetration. This strengthened bridge will likely serve the community for another century!
