CDOT Geohazard Management Plan Evolution

A leap forward with open source lidar and new algorithms

Mark Vessely, P.E., BGC Engineering

May 21, 2024

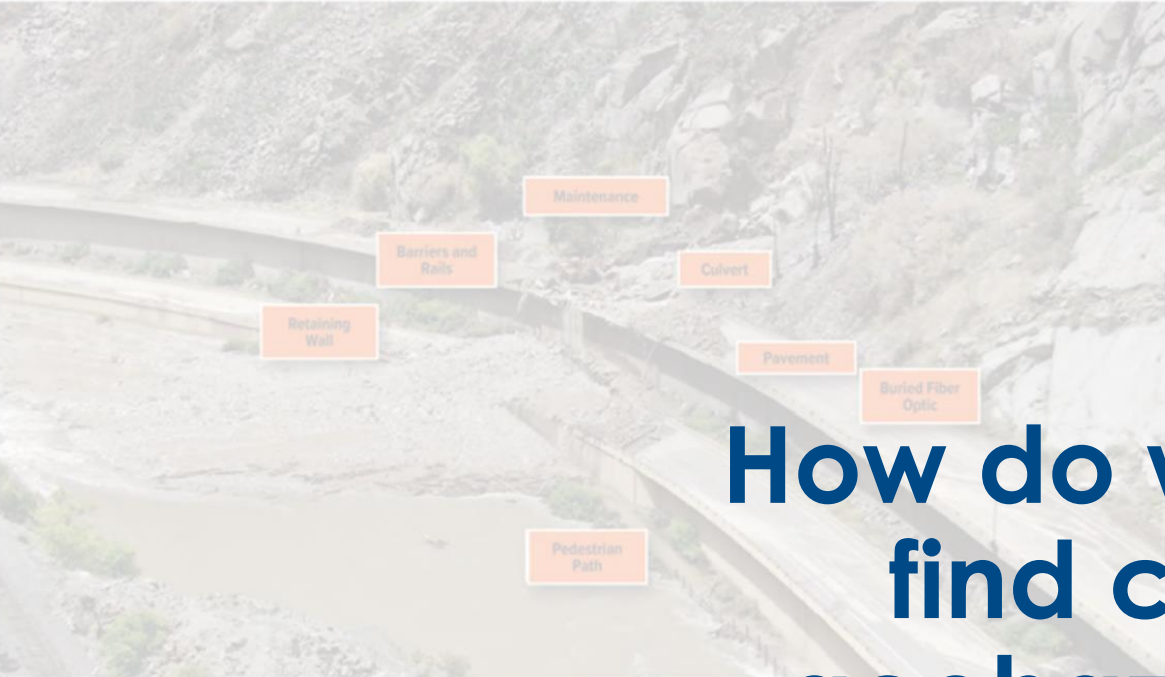
Maintenance

Barriers and Rails

Culvert

Pavement

Buried Fiber Optic

Retaining Wall

Pedestrian Path

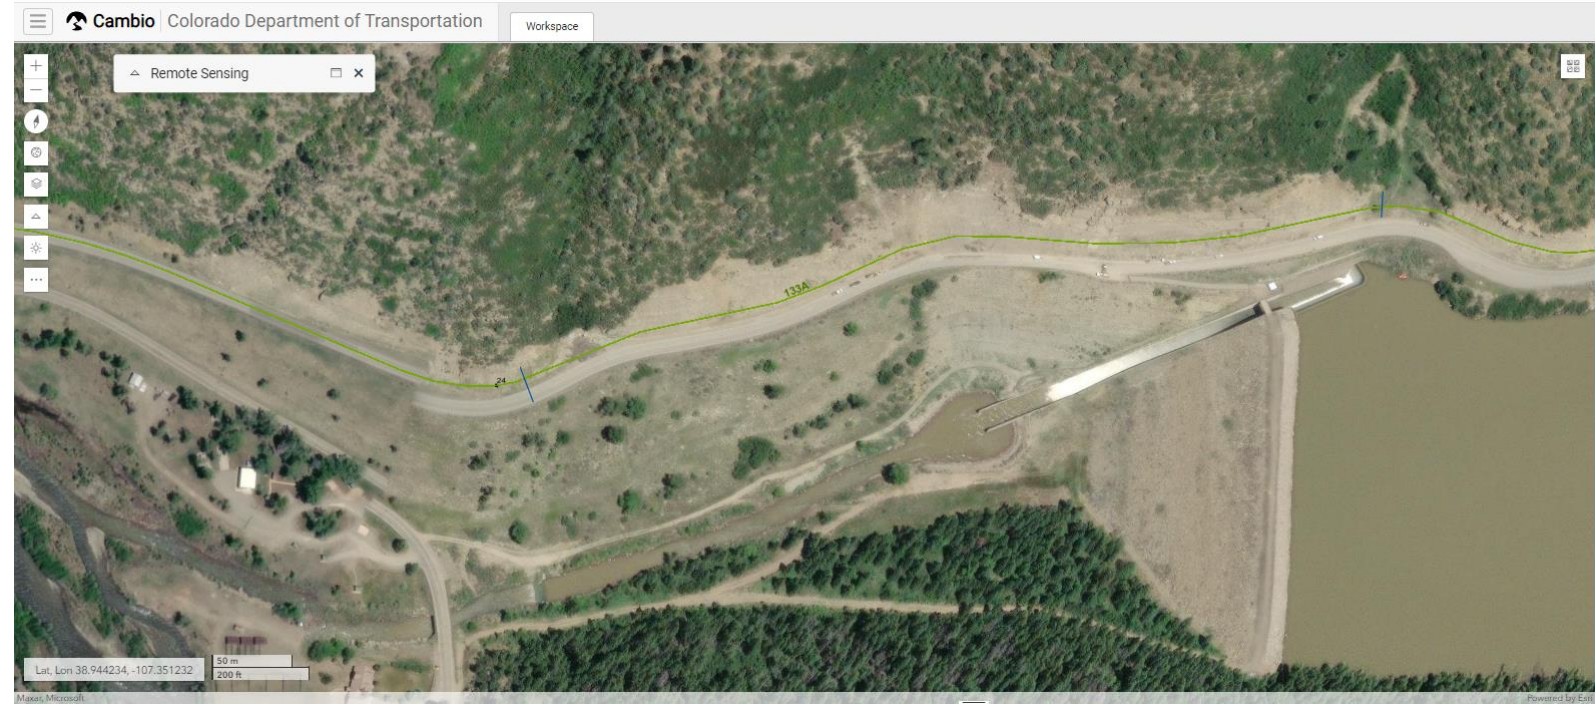
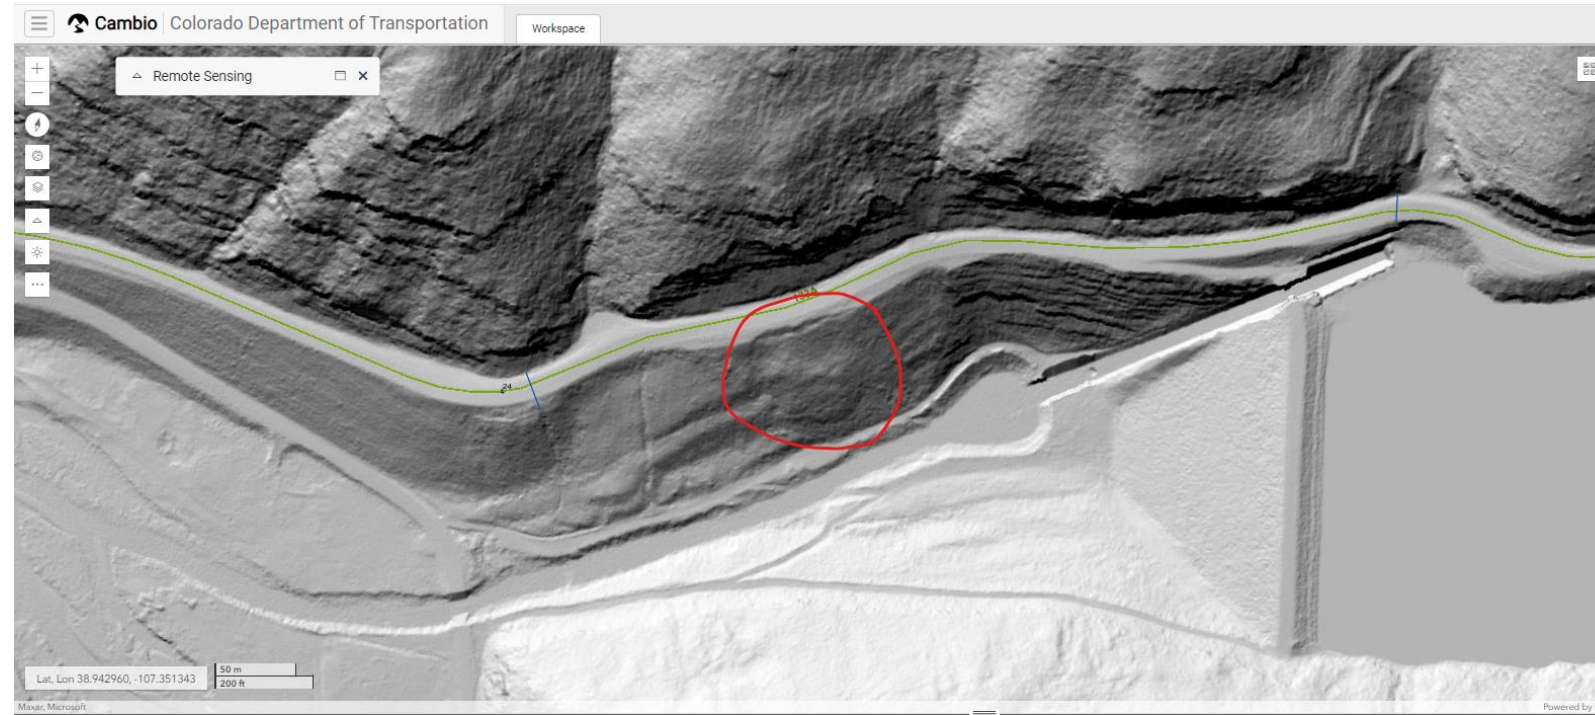
Aerial imagery vs. Bare Earth Lidar

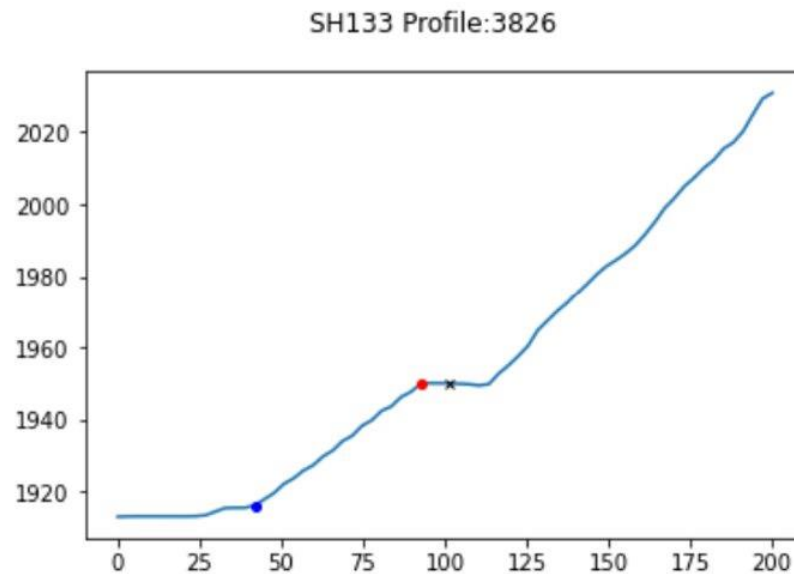
(2) Identify continuous slopes over a specified gradient, height and distance to the roadway

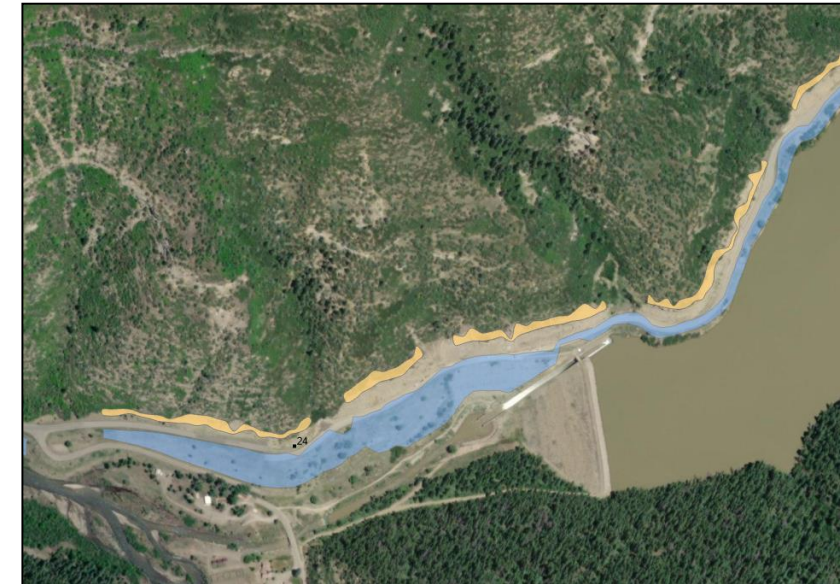
(3) Outputs include polygons representing the credible geo-asset or geohazard

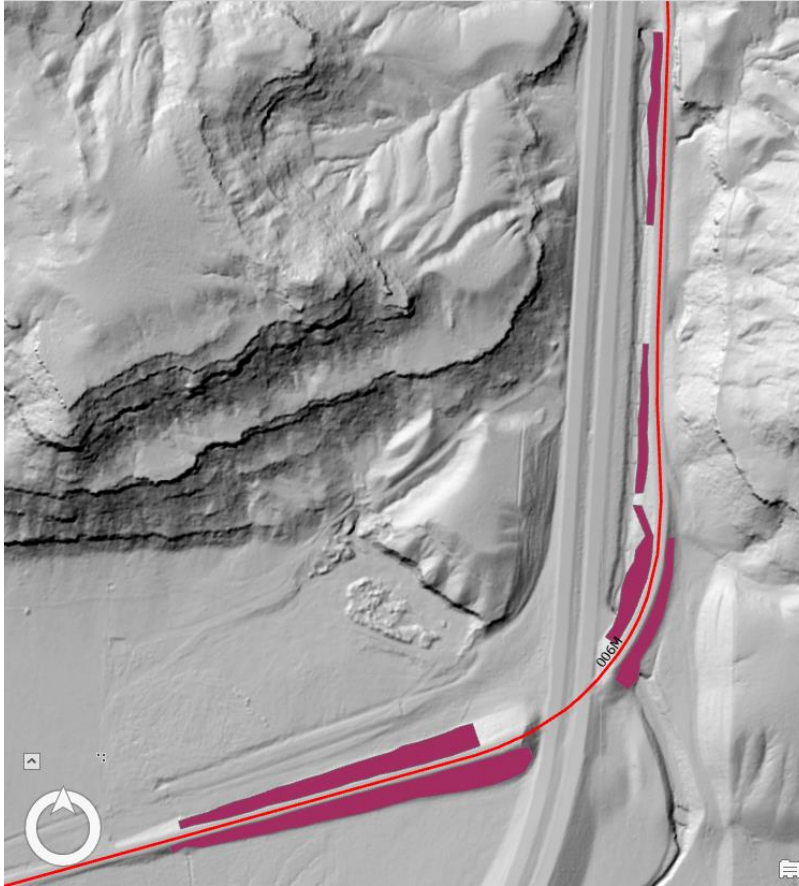
Example output – embankment assets
